SOLID WASTE DIVISION

Stormwater Piping Repair at the Middlesex County

Landfill

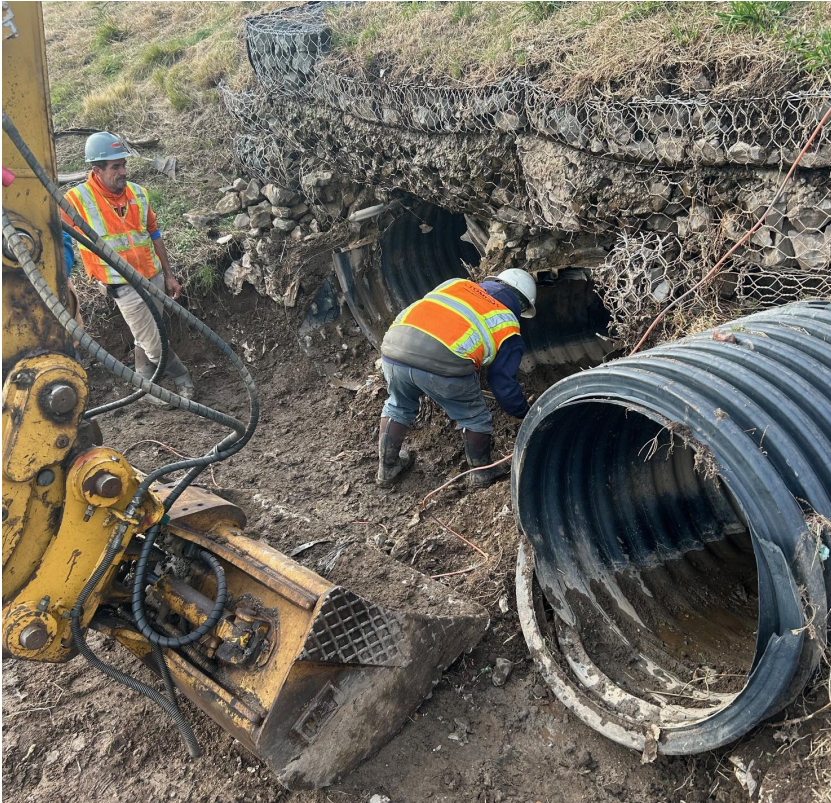
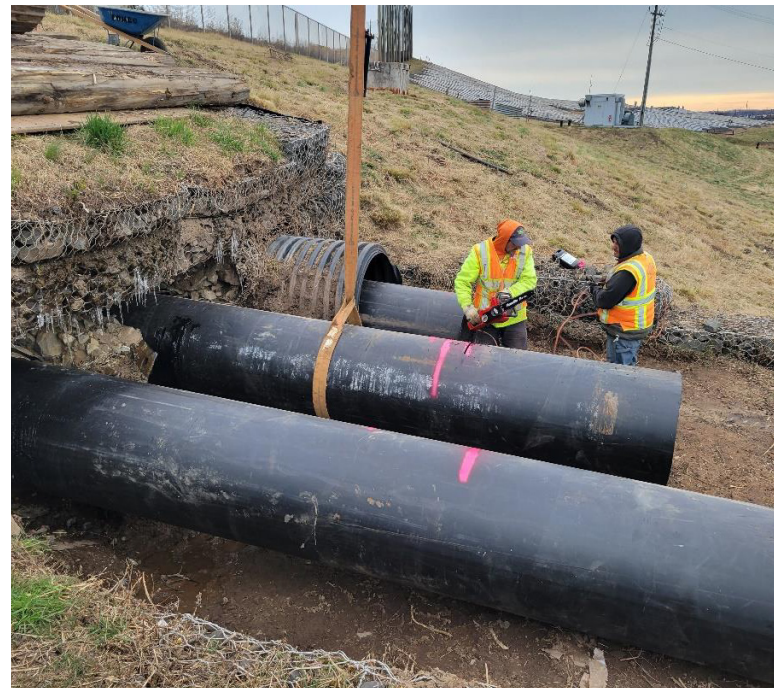
The Landfill's Annual Stormwater Inspection Report identified that the ends of three 42-inch corrugated HPDE pipes had been deformed by the weight of gabion baskets. The three pipes and gabion baskets are part of Downchute A of the existing final landfill cap and are located on the Southeastern side of the Landfill.

The project to repair the pipes consisted of removing the deformed ends of the existing 42-inch HPDE pipes and lining them with new 30-inch HDPE pipes. The void space between the existing and proposed pipes was filled with a grout mixture. The existing gabion baskets above the pipes were removed and the slope was graded and stabilized with riprap.

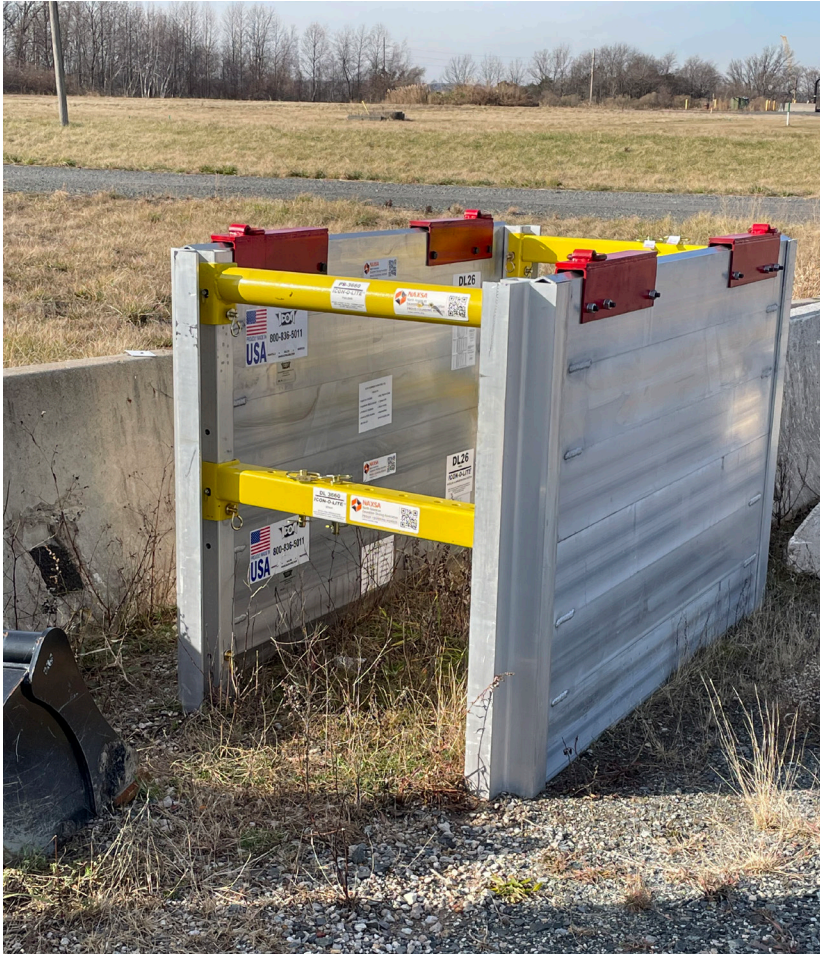
Trench Boxes for Underground Repairs

Recently, MCUA purchased two different sized trench boxes for our field employees. Trench boxes are used to protect workers while performing tasks within an excavation area. These trench boxes are steel or aluminum structures that are inserted into a trench or other excavation to secure the sidewalls from cave-in or erosion. The sidewalls of a trench box are held apart by spreaders, which can be customized to match the width of the excavation.
